# CONCRETE CANVAS™

## DITCH LINING CASE STUDIES

The Caserones Project is a ditch-lining project located in the 3rd Region of Atacama, 800 kilometres to the north of Santiago, with the aim of diverting glacial melt water that threatens to flood a nearby copper mine, owned and operated by Minera Lumina Copper Chile (MLCC). The project was being undertaken in a remote and challenging environment, with the bulk of the installation over 4,000m above sea level in an area subject to temperatures ranging from -10°C to 20°C.

## 14.09.09 Case Study : Chipping Sodbury

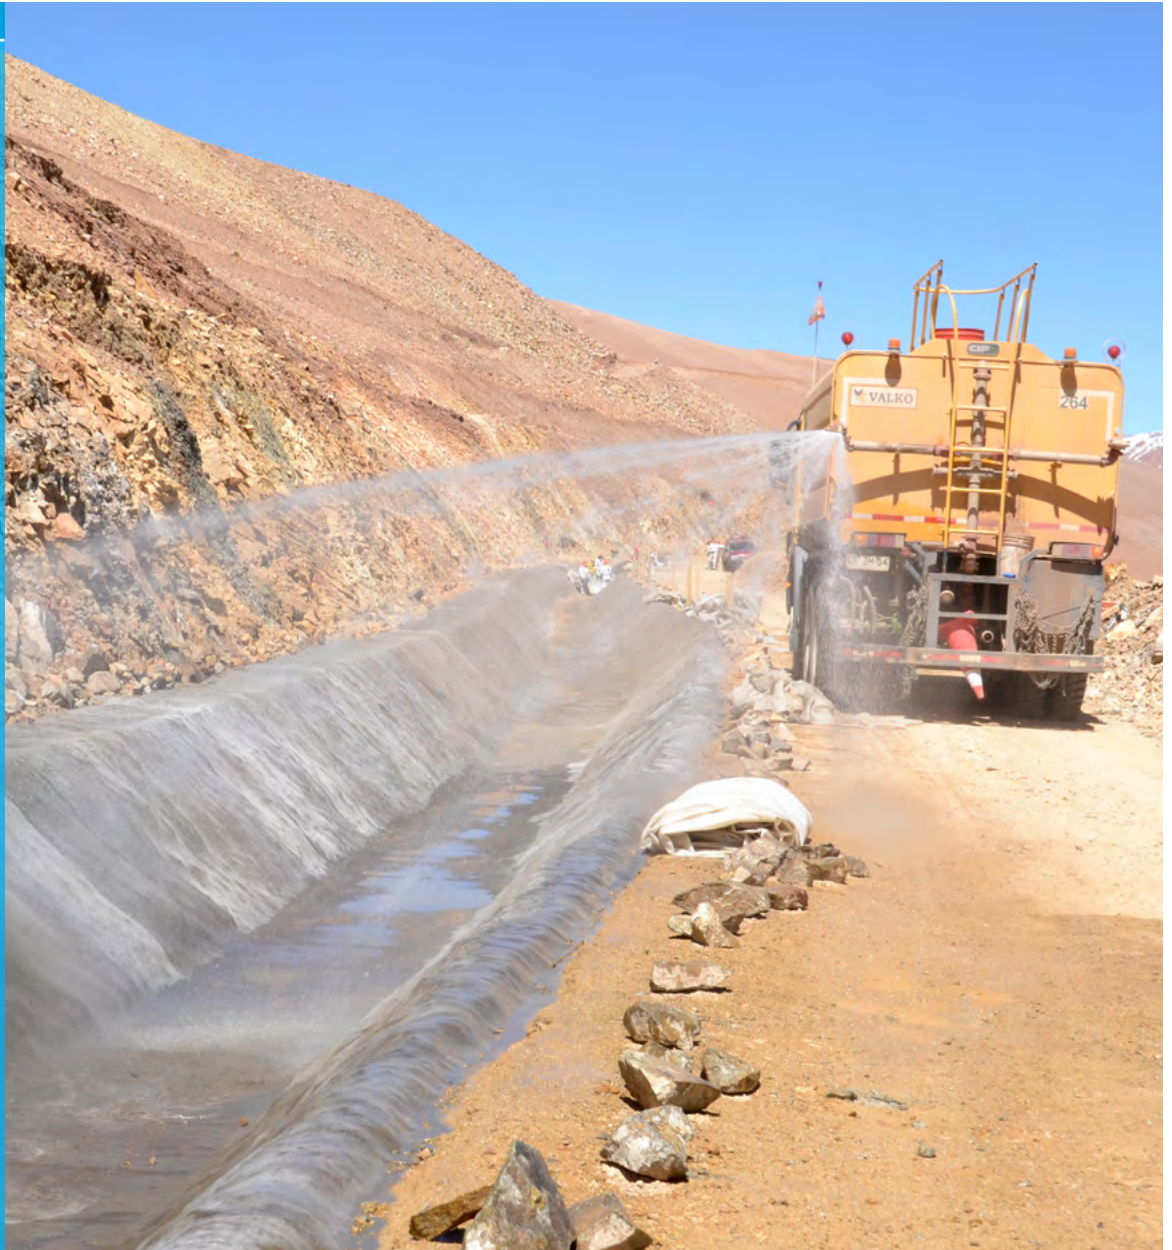
Section of CC-lined ditch undergoing hydration

CC5 was delivered to site in bulk rolls and dispensed using a spreader beam and crane truck. Lengths of 6.4m were cut on site to allow the CC to be laid across the width of the ditch, then held in place with ground pegs before being buried in an anchor trench situated at the head of the ditch sides. Adjoining layers of CC were overlapped by 100mm in the direction of water flow and held together with screws. The CC was hydrated using a sprayer truck, dispensing water that had been mixed with a CC-approved accelerant to help the material set faster in the cold environment. The hydrated CC was then covered in plastic sheeting for three days to again protect it from freezing temperatures during setting.

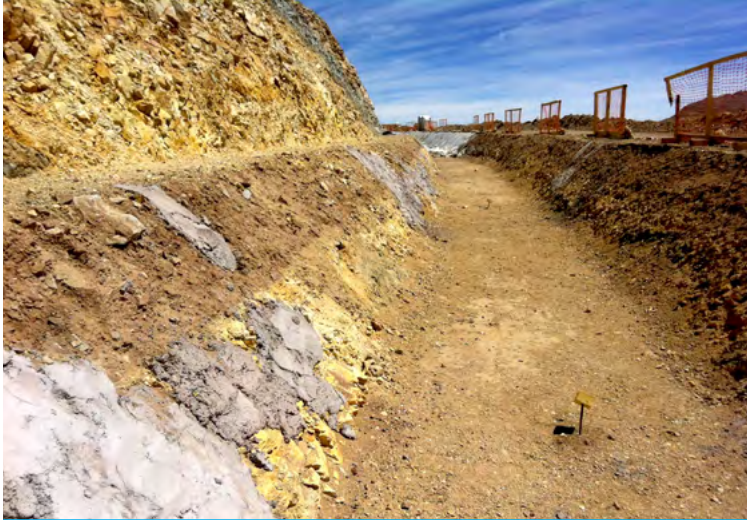
The ditch was graded and cleared of rocks and debris prior to installation

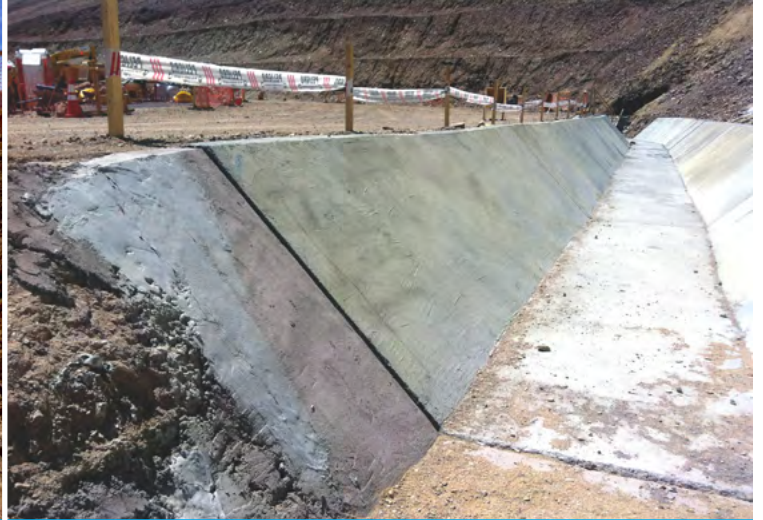
Parts of the ditch had been lined using poured concrete in the past

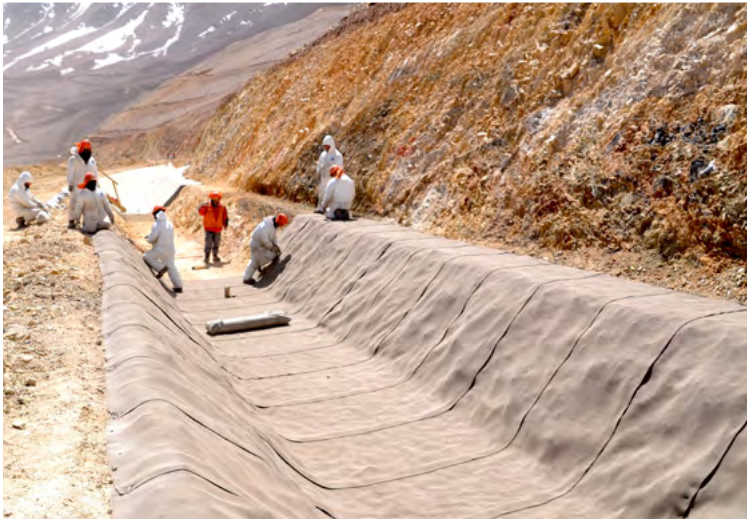
CC pegged to head of ditch edges and buried in anchor trench

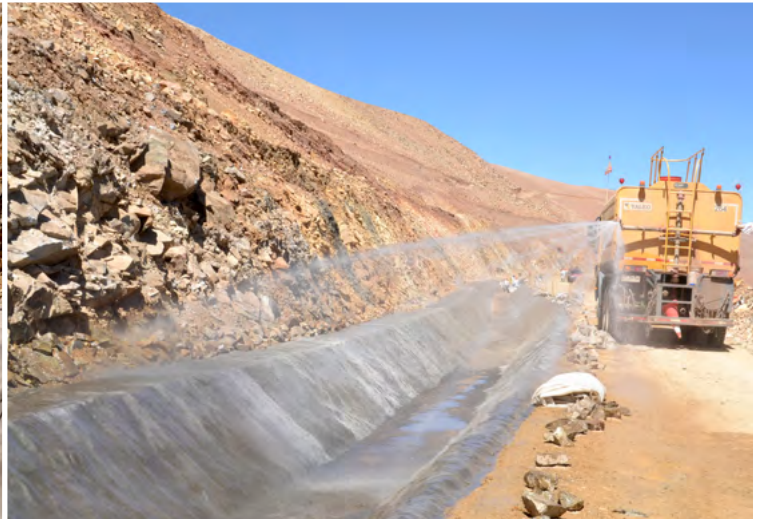
Water/accelerant mix dispensed from water tanker during hydration

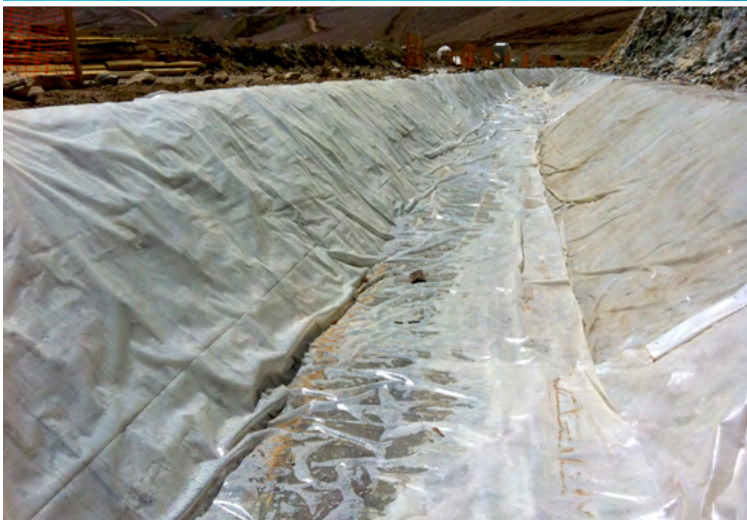
Hydrated CC covered with plastic sheeting to protect from low temperatures

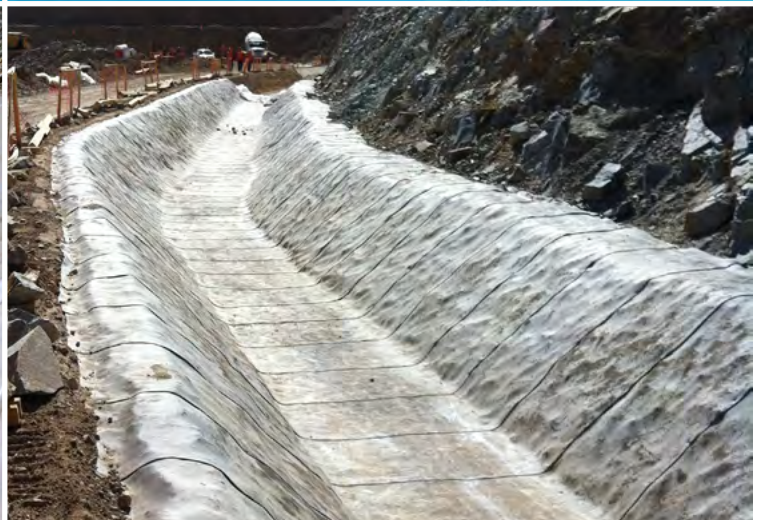
Completed lined section of ditch

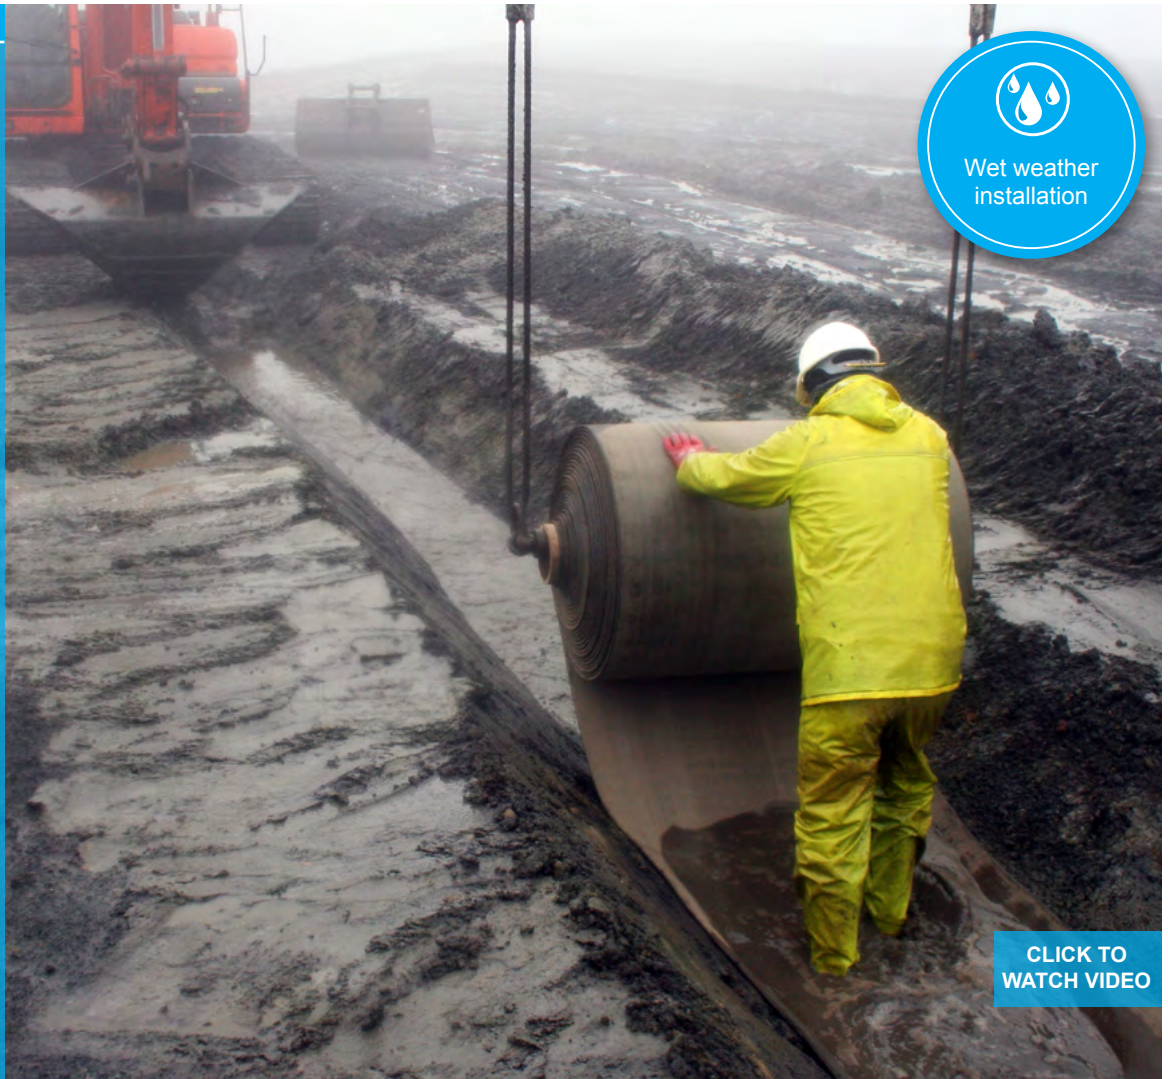
Installation of single layer of CC13 along channel in wet conditions

The ability of Concrete Canvas to be installed in wet weather significantly reduced disruption to the project.

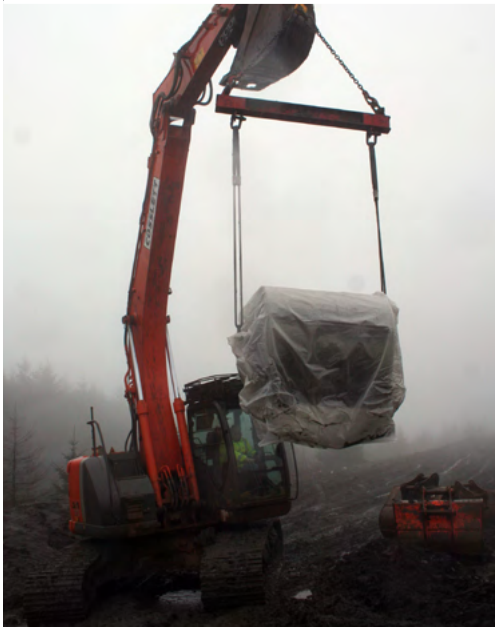
CC bulk roll transported to site

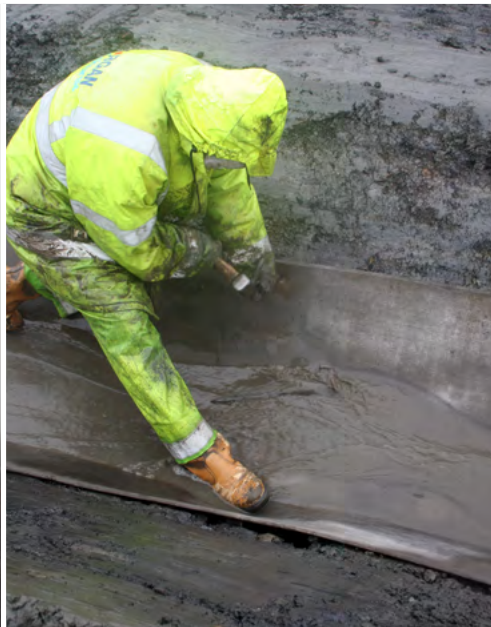
CC secured to substrate with pegs

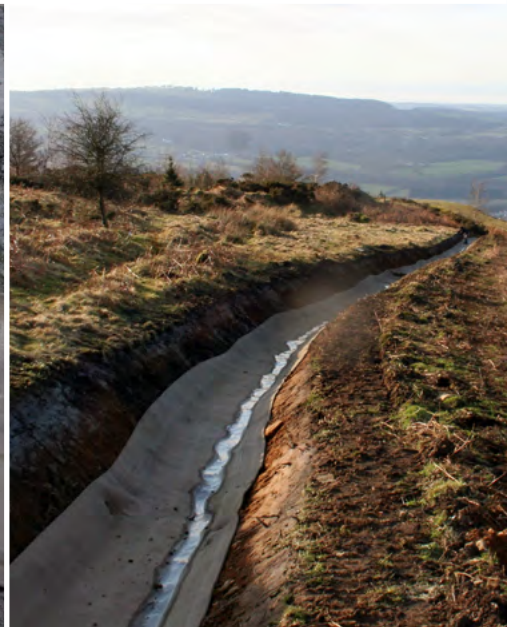
Completed CC lined channel

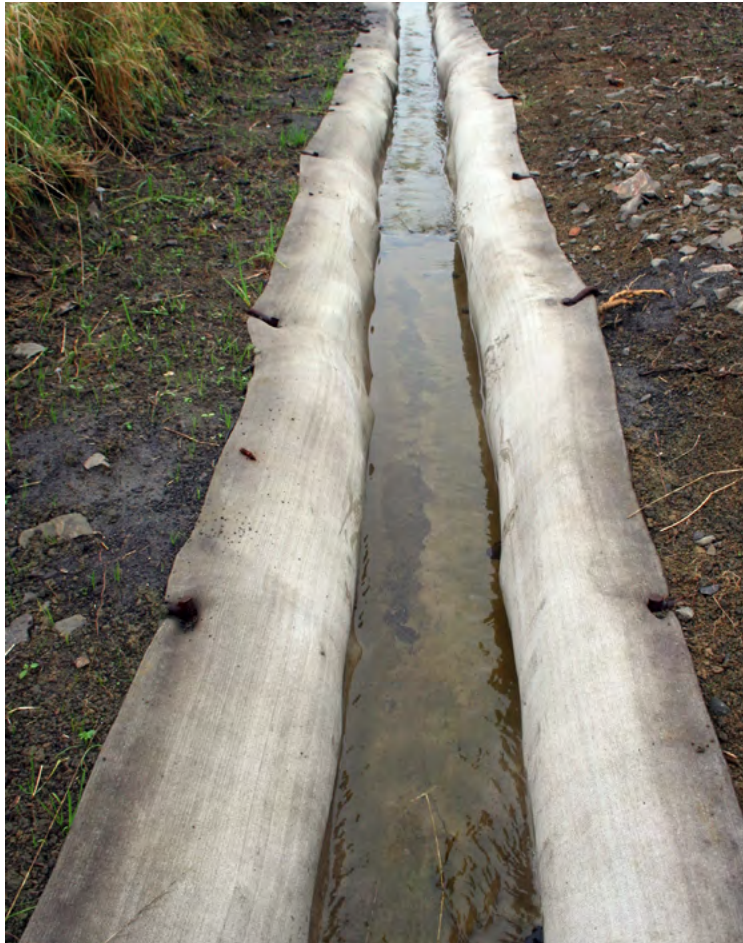
Completed ditch with water flow

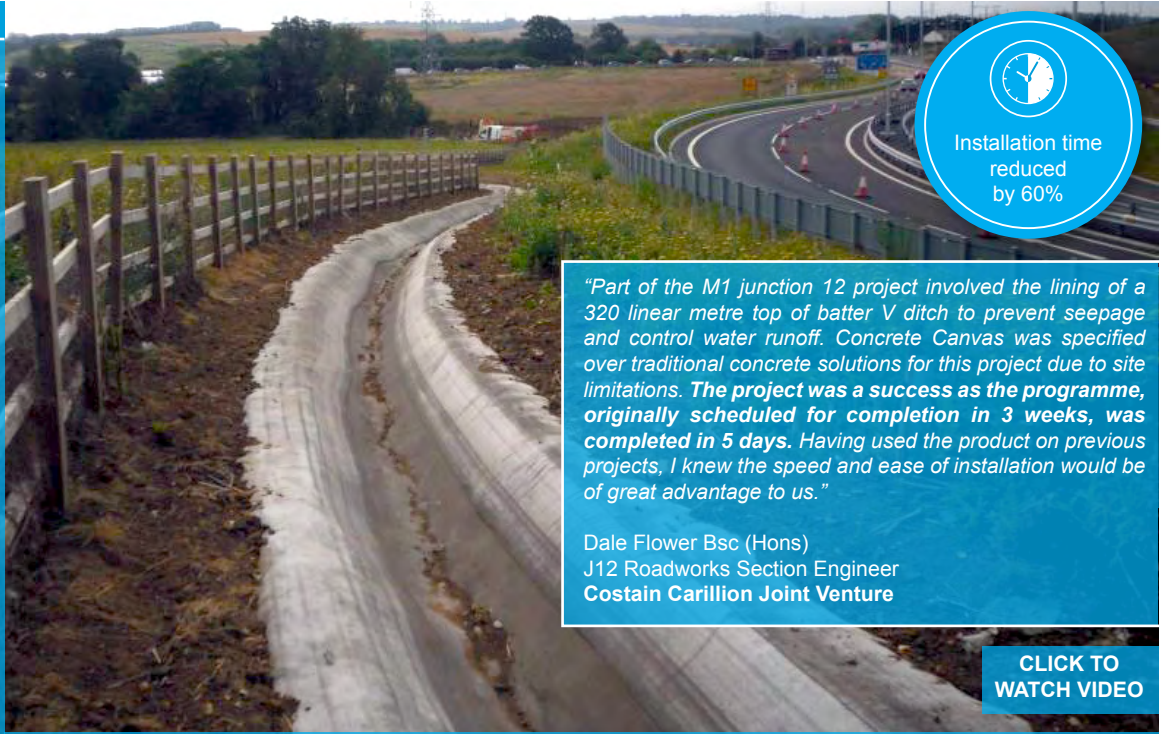
Completed lined ditch section

"Part of the M1 junction 12 project involved the lining of a 320 linear metre top of batter V ditch to prevent seepage and control water runoff. Concrete Canvas was specified over traditional concrete solutions for this project due to site limitations. **The project was a success as the programme, originally scheduled for completion in 3 weeks, was completed in 5 days.** Having used the product on previous projects, I knew the speed and ease of installation would be of great advantage to us."

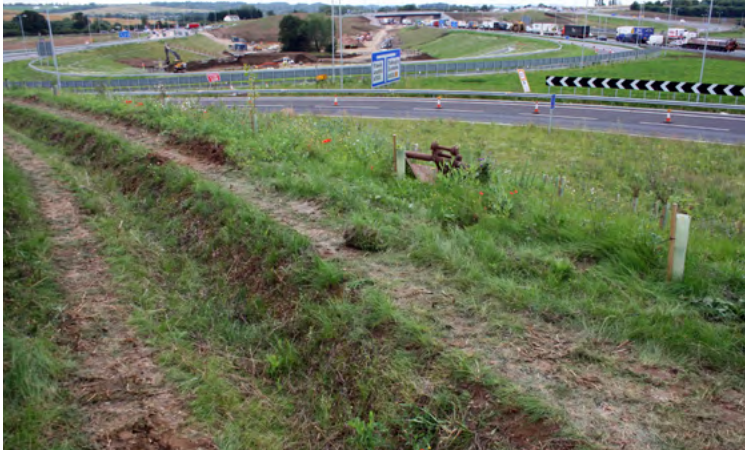
Batter prior to ditch excavation.

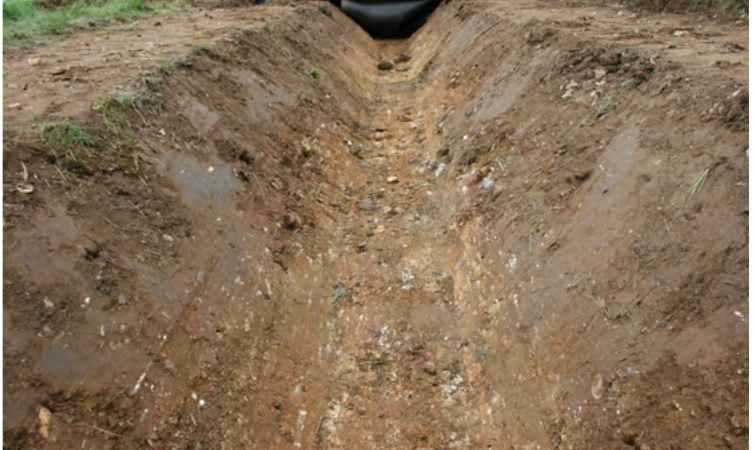
Graded ditch section with vegetation removed.

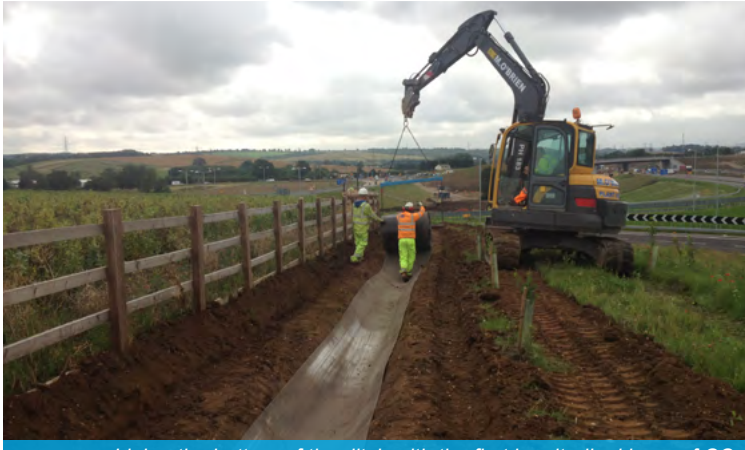
Lining the bottom of the ditch with the first longitudinal layer of CC

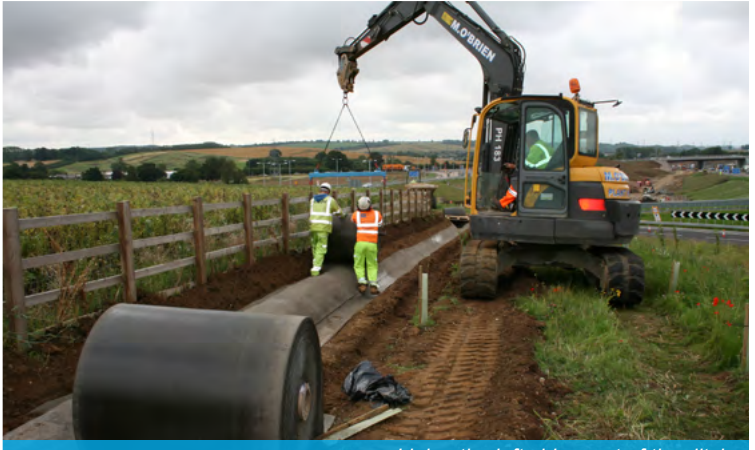
Lining the left side crest of the ditch

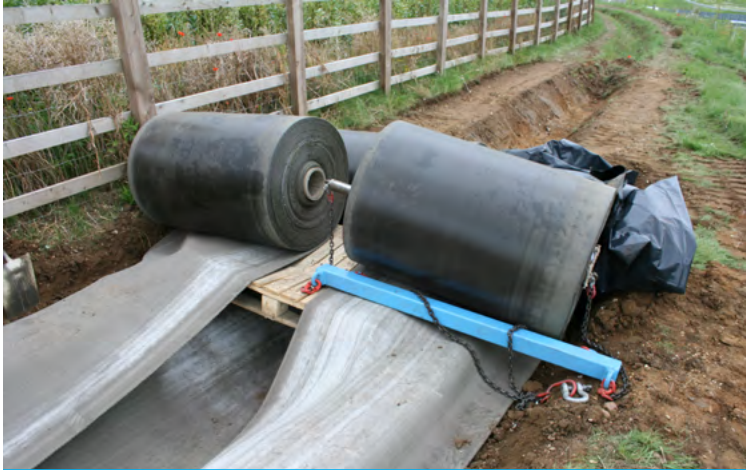
CC Bulk rolls arranged for installing three longitudinal layers

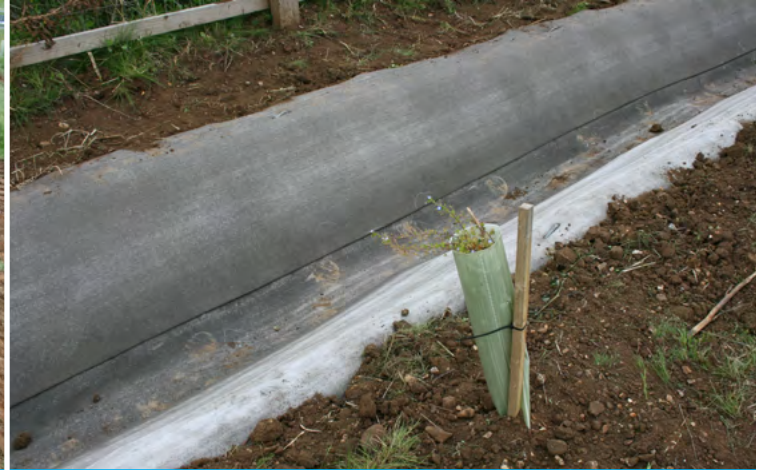
Detail showing overlap between longitudinal CC layers

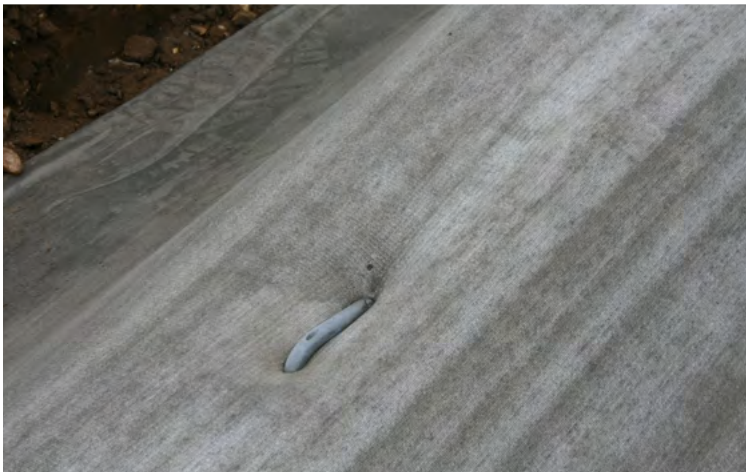
CC was secured with steel ground pegs at 2m intervals.

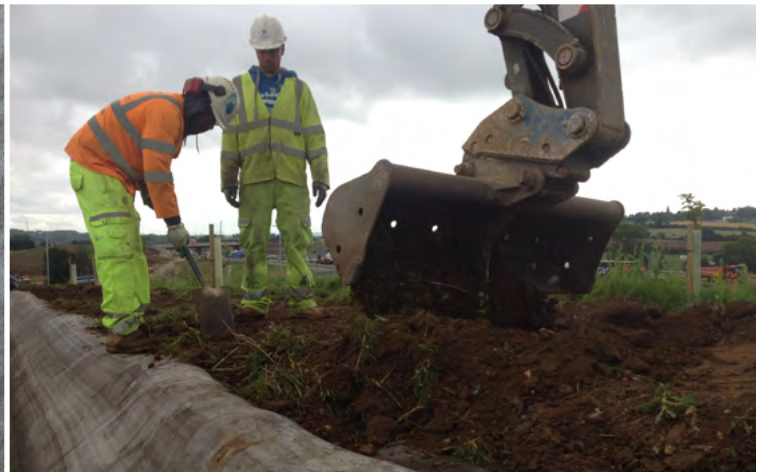
The edges of the CC were anchor trenched and backfilled after hydration.

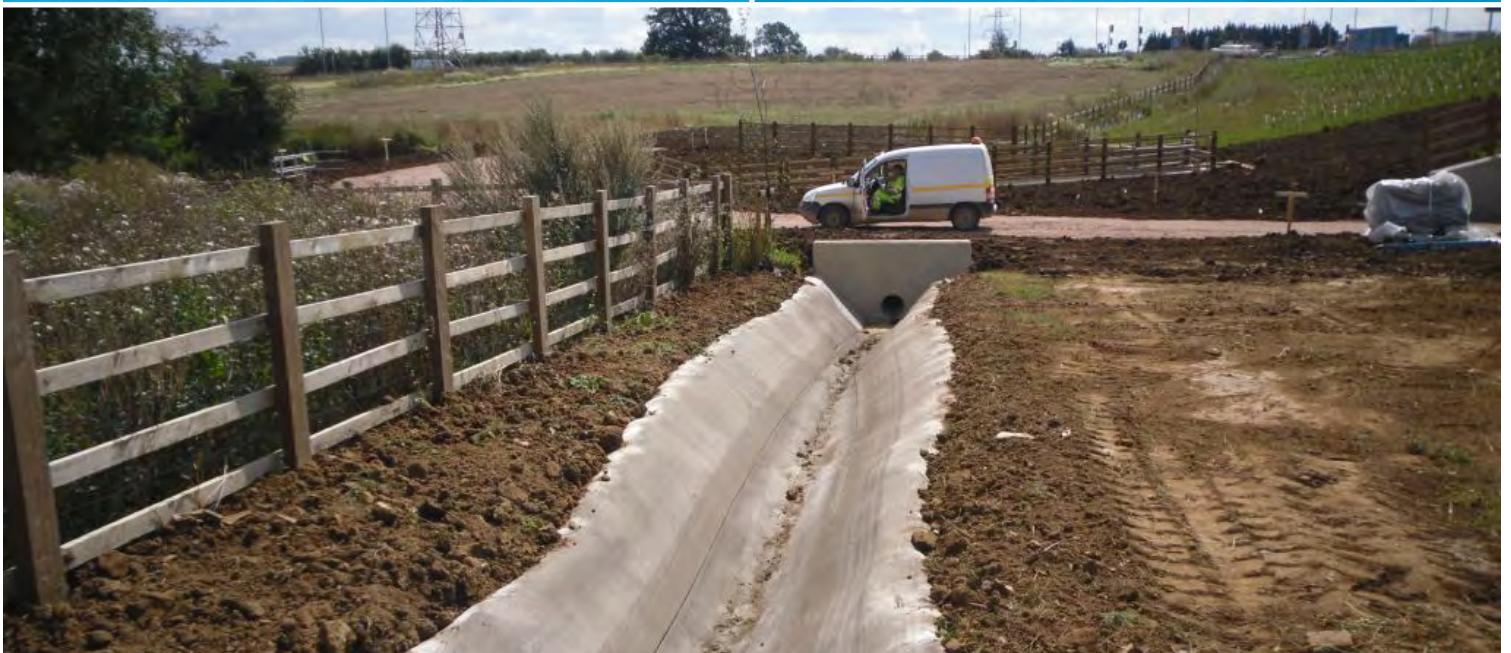
Completed CC ditch section terminating in concrete culvert.

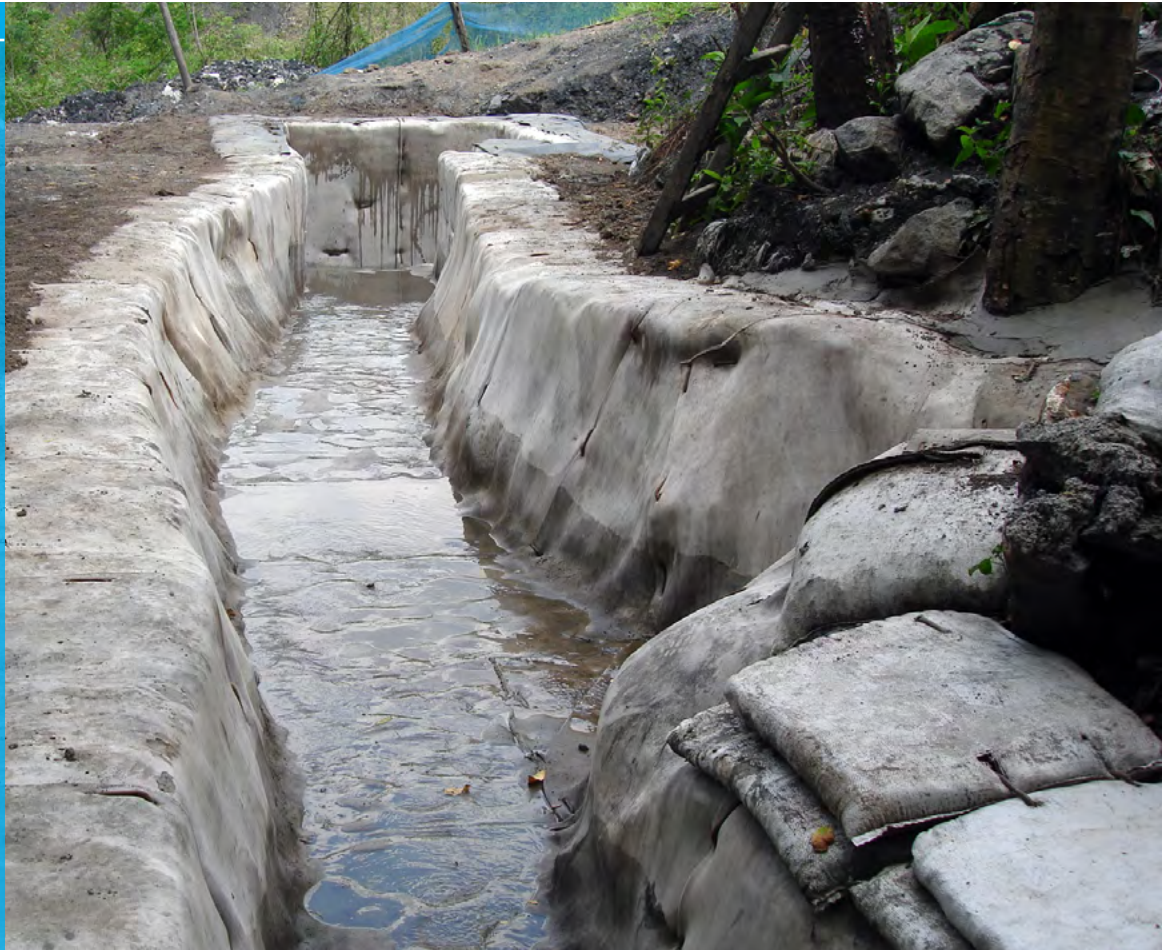
Completed CC lined trap

CC lining of a sand bag constructed trap. The trap is designed to reduce water velocity and turbulence which allows solid material transported in suspension to settle to the bottom of the trap before removal.

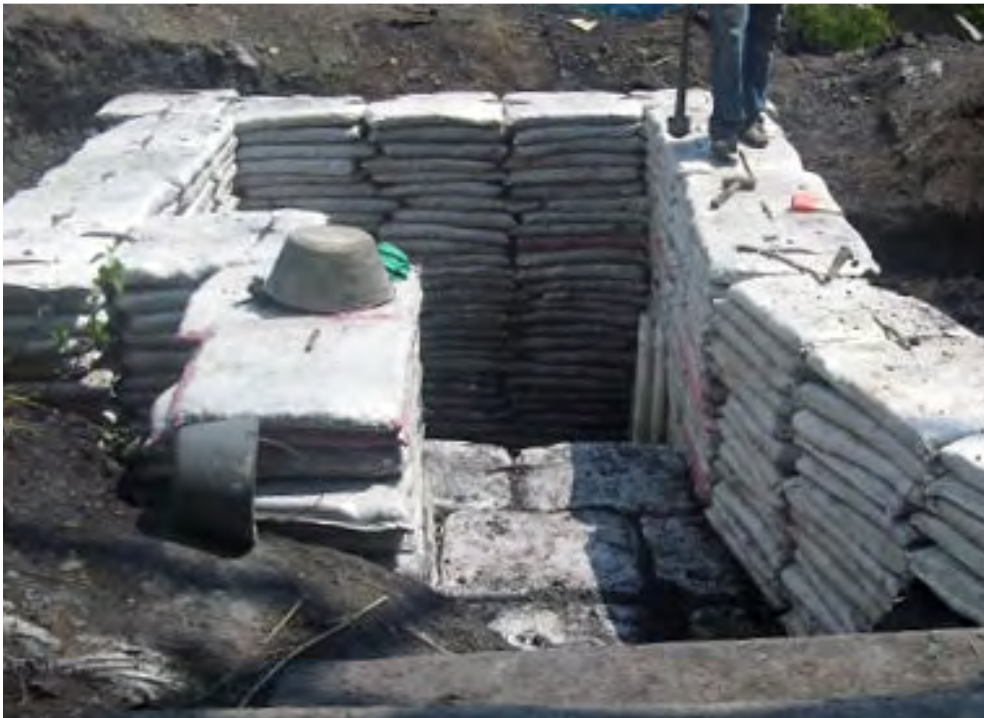
Construction of the trap using sandbags which if not lined with CC, would eventually degrade due to water erosion and UV degradation

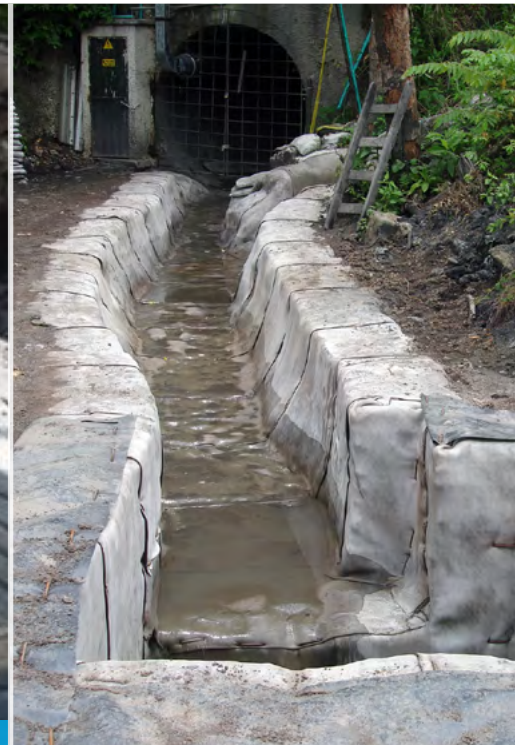
CC fixed with re-bar fixings
